2010 Monitoring Summary

Pepperell Branch upstream of Sougahatchee Creek behind Opelika Westside WWTP in Lee County (32.66030/-85.44870)

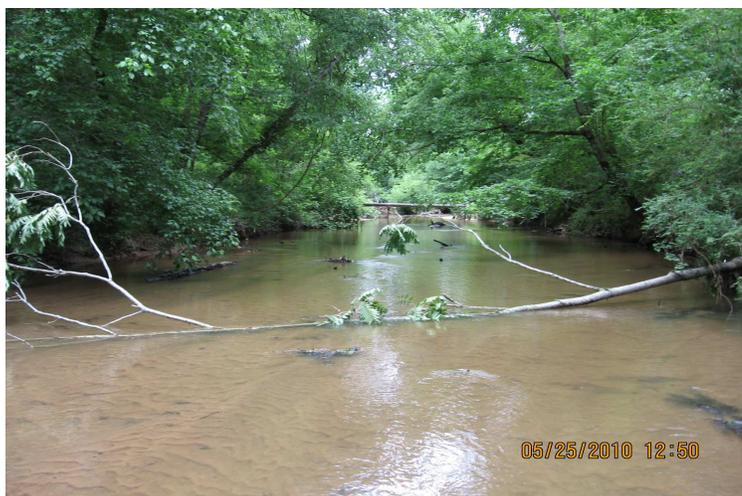
Figure 1. Pepperell Branch at PPLL-5, May 25, 2010.

General observations (Table 2) and a habitat assessment (Table 3) were completed during the macroinvertebrate assessment. In comparison with reference reaches in the same ecoregion, they give an indication of the physical condition of the site and the quality and availability of habitat. Pepperell Branch at PPLL-5 is a sandy-bottomed, mostly-shaded stream reach (Figure 1). Overall habitat quality was categorized as *marginal*.
